Appendix 2: 1995 photographs of Cuerda de Lena. All photographs by S. Rutman, Organ Pipe Cactus National Monument, March, 1995.

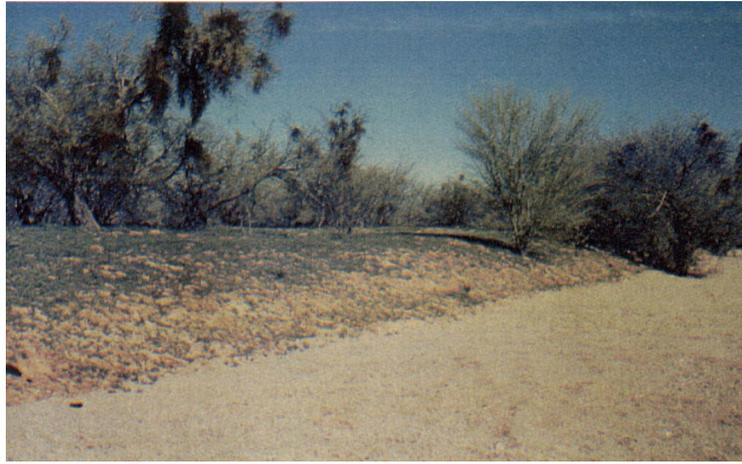
Photograph 1a. West bank of the western branch of Cuerda de Lena at the north boundary of the Monument, looking north onto public lands managed by the Bureau of Land Management. The riparian zone has patches that are devoid of woody perennials; remaining trees are hedged. The wash bank is chiseled by livestock. Vines are scarce or absent.

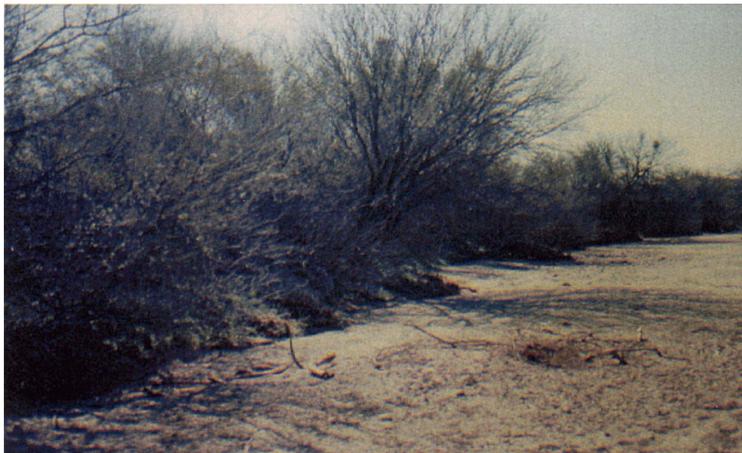
Photograph 1b. East bank of the west branch of Cuerda de Lena at the north boundary of the Monument, looking south onto public lands managed by the NPS (wash bed in foreground). Trees line the riparian zone, and understory growth is abundant. Note the vine *Clematis drummondii* (Virgin's bower) in the tree in the left foreground; this species is abundant along Cuerda de Lena within the Monument.

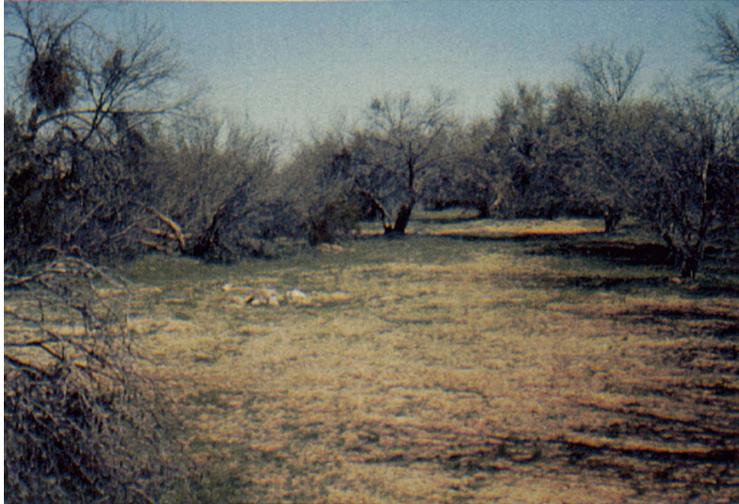
Photograph 2a. West of the western branch of Cuerda de Lena, looking north of the northern boundary of the Monument on lands managed by the Bureau of Land Management. Note the general lack of understory perennials, especially vines, and the hedged appearance of the trees.

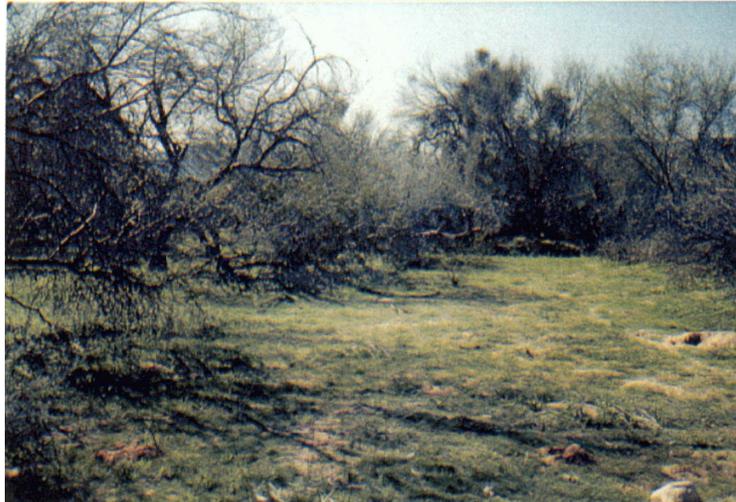
Photograph 2b. West bank of the western branch of the Cuerda de Lena, looking south onto public lands managed by the National Park Service. Trees have begun to regain natural form and understory perennials were common. Open spaces have yet to recover, although one young creosote bush had colonized the open area (near center).

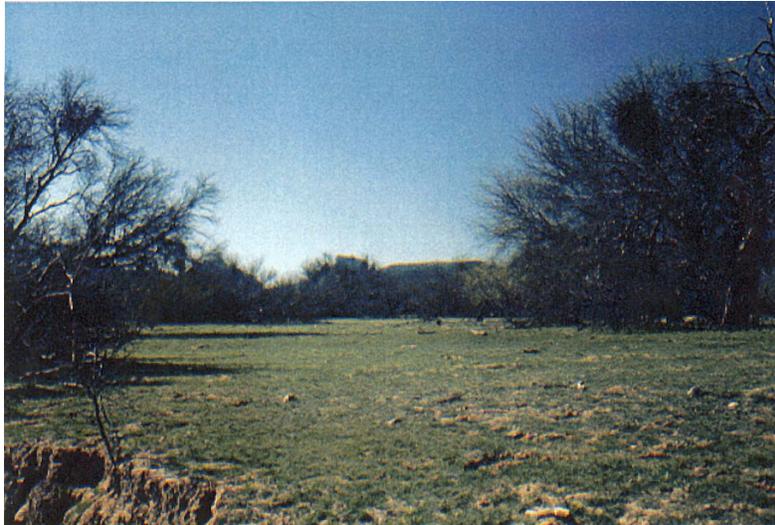
Photograph 3. West side of Cuerda de Lena, about 1/4 mile north of the Monument's north boundary. Large barren areas have developed where there are no mature or young perennial plants. Note the young tree rooted in the eroding and chiseled wash bank.

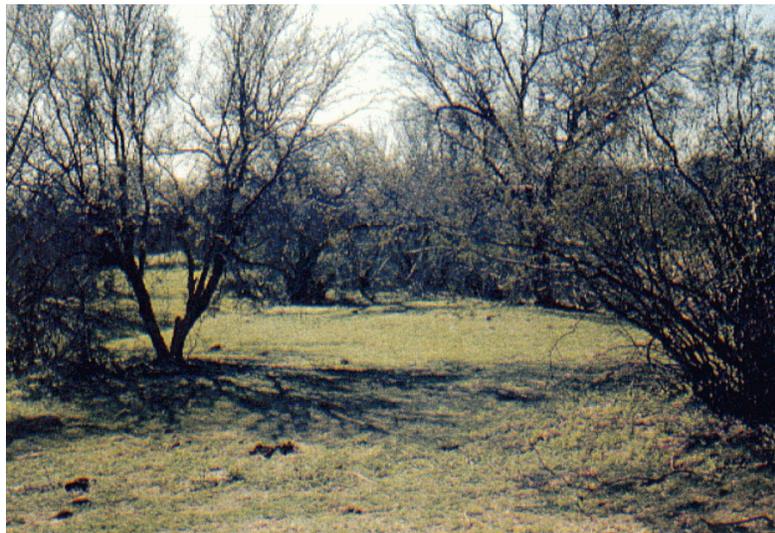
Photograph 4. West side of the degraded Cuerda de Lena riparian area, on Bureau of Land Management land near the north boundary of the Monument. A view of the large open areas lacking woody perennials. The mesquite trees (left center and background right) are hedged, as is the large creosote bush (right center).

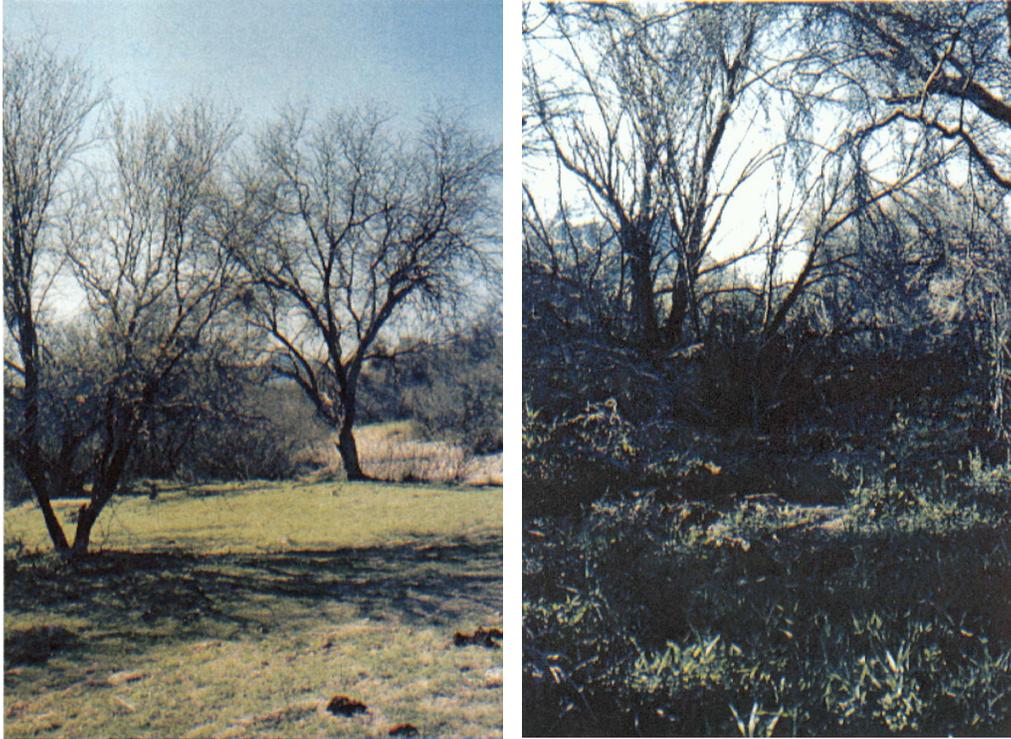
Photographs 5 (left) and 6 (right). Photograph on the left was taken on the west side of Cuerda de Lena, on Bureau of Land Management land about 1/4 mile north of the north boundary of the Monument. The riparian zone was open, trees were hedged, understory woody perennial cover and density was low, and a lot of sunlight reached the soil surface. Photograph on the right was taken on the west side of Cuerda de Lena, on the Monument just south of the north boundary. Photographs of the riparian forest here were difficult to take because light was low and general tangle of vines and other understory shrubs prevented a view.

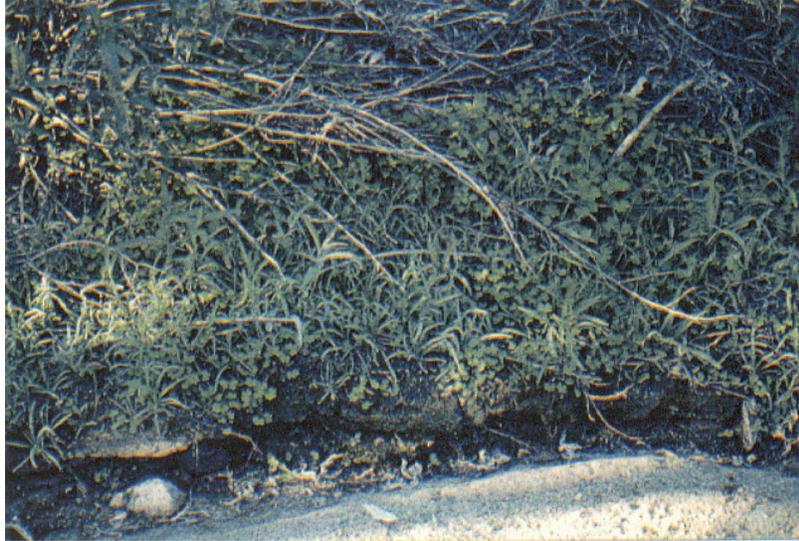
Photograph 7. The bank of Cuerda de Lena, on the Monument near the north boundary. Note the discrete interface between the active stream bed (white sand/gravel) and the wash bank. A cryptobiotic soil crust stabilized this interface, even in the flood-scour zone. Mosses were an important component of the soil crust. The discrete interface and presence of cryptobiotic soil crust along the wash banks was typical of most but not all of the Cuerda de Lena on the Monument.

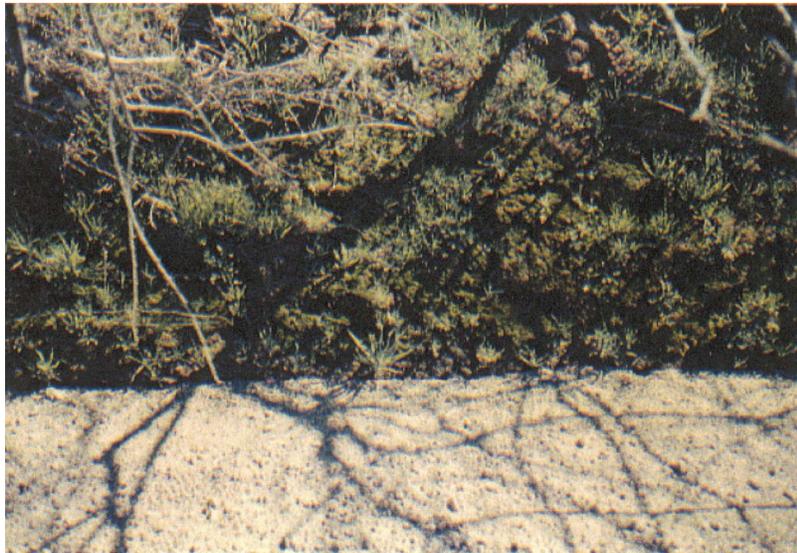
Photograph 8. The bank of Cuerda de Lena, on the Monument near the north boundary, showing another view of the discrete interface between the active stream bed (white sand/gravel) and the wash bank.

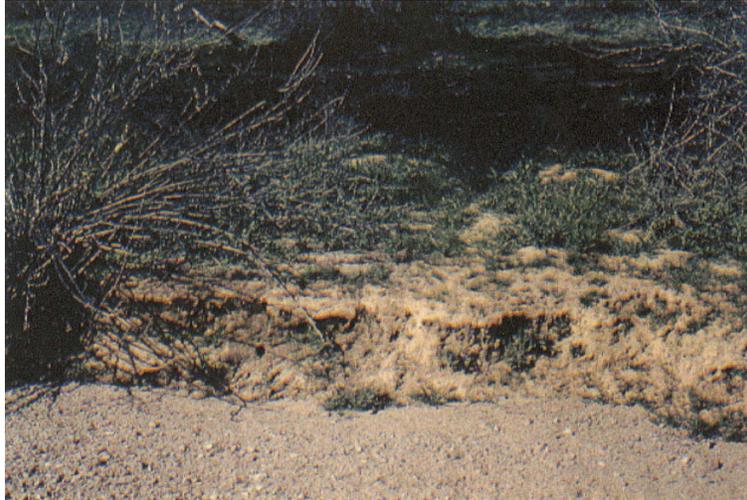
Photograph 9. The bank of Cuerta de Lena, on Bureau of Land Management land north of the Monument's north boundary. The banks of the wash were destabilized and devoid of cryptobiotic soil crust. The canyon ragweed (*Ambrosia ambrosioides*) on the left side of the photograph was being undercut by bank erosion.

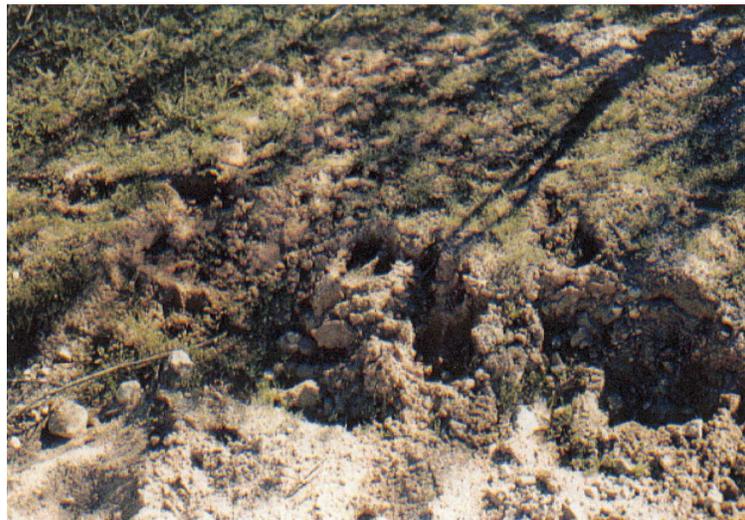
Photograph 10. The bank of Cuerta de Lena, on Bureau of Land Management land north of the Monument's north boundary. Close-up of the area in Photograph 9. Cattle were chiseling the wash bank. Establishment of woody perennials would be difficult if not impossible under these conditions.

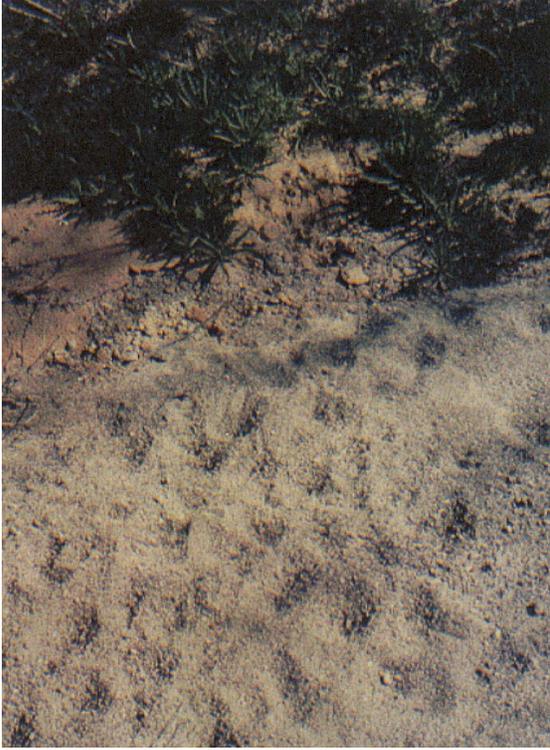
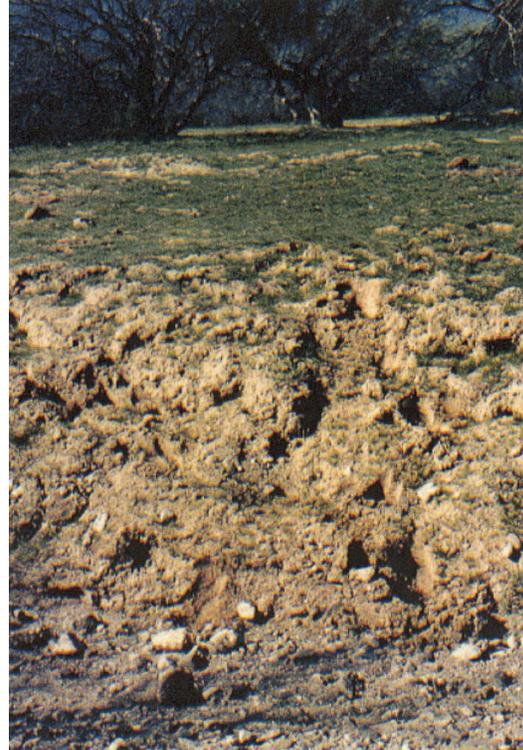
Photograph 11 (left) and 12 (right). Comparison of deer crossing versus livestock crossing of Cuerda de Lena. A deer trail (left) across a bank of Cuerda de Lena was narrow. Livestock crossed where convenient and caused widely dispersed impacts.
